**Observation and Microscopy
of
New and Weathered Innowood**

**by
Dr Tim Dabbs**

5th April, 2018

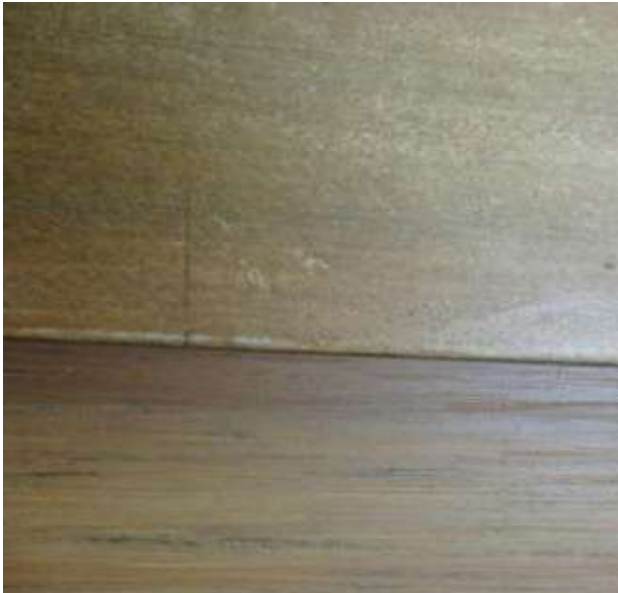
Figure 5 – Sample D exposed face (top) held against the Tasmanian Oak colour sample.

It was difficult to draw conclusions about colour changes due to weathering for sample D (Figure 5) as it had been recoated with a stained coating. If the back face of sample D was originally 'Tasmanian Oak' in colour, ageing, whether it had been exposed to the elements or was unexposed, may have led to a lightening in tone and greying in hue. Based on evidence from the other samples, it seemed more likely that Sample D was not originally 'Tasmanian Oak' in colour.

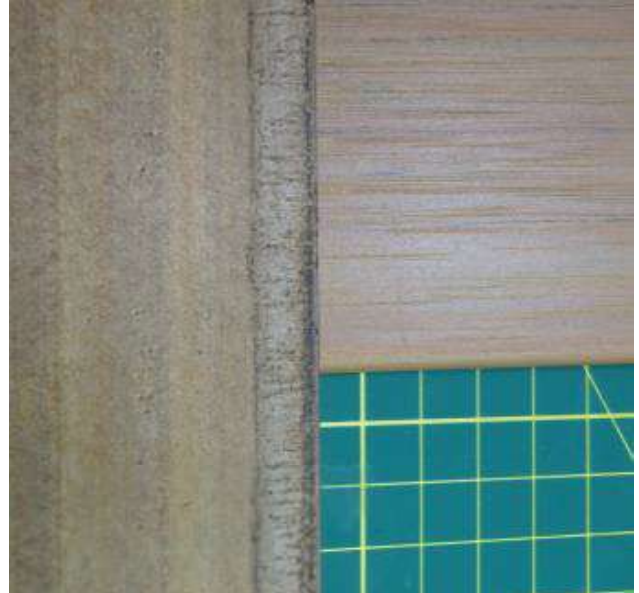
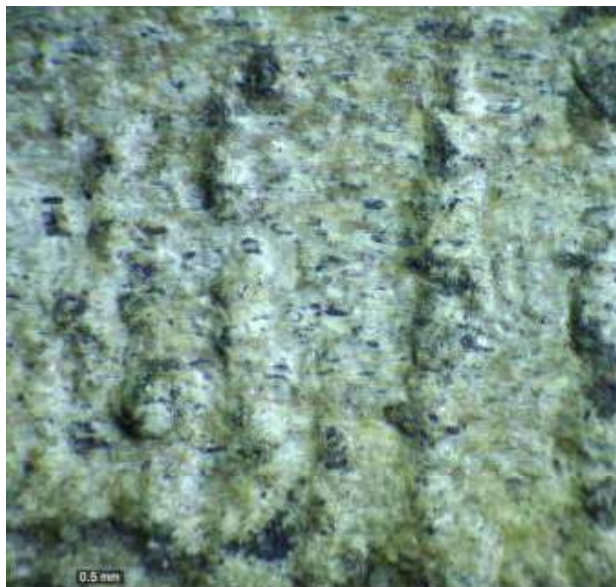
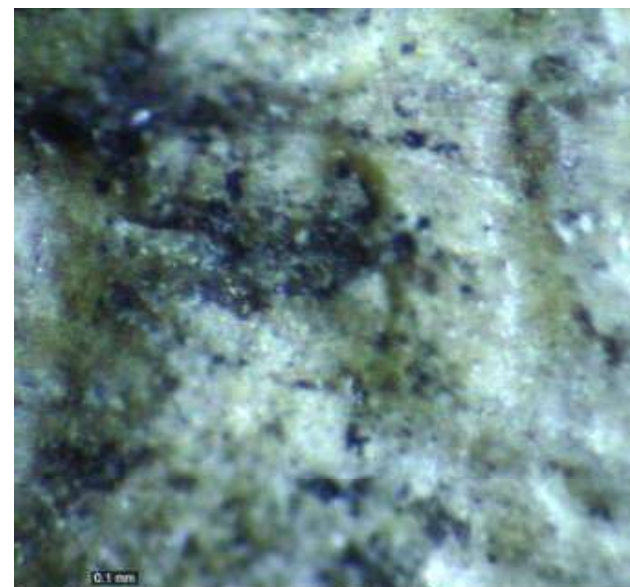
Figure 6 – Sample D rear face (left) held against the Tasmanian Oak colour sample. An eroded strip can be seen to the right of Sample D.

Figure 25 – Micrograph of the rear face of Sample D at low magnification in the region of the edge where grooves appear to have been formed in the surface.

Figure 26 – Micrograph of the rear face of Sample D at high magnification in the region of the edge where grooves appear to have been formed in the surface.

Figures 6, 25 and 26 show evidence of mechanical, chemical or biological erosion of small grooves in one back edge of Sample D; attack by ants seems most likely. The erosion is confined to less than 1 mm of depth, the surface of the erosion grooves was still sound, as hard as the rest of the sample (as measured by the depth of the indentation caused by very firm thumbnail pressure) and looked similar to the remainder of the sample (albeit without a coating). This suggests that while the Innowood had not prevented any damage from occurring, it can be considered resistant to such attack (as claimed in the on-line literature).

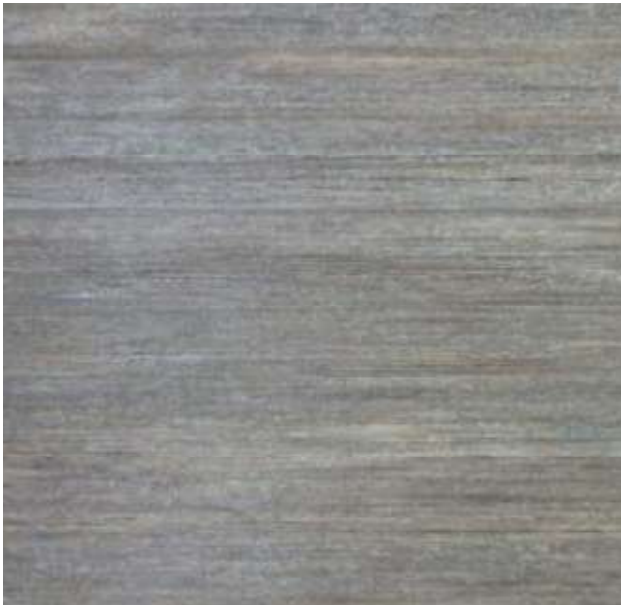
Figure 9 – Sample F front (sanded) face.

For sample F, the original colour was unknown and the front face had recently been sanded, so it was impossible to determine whether the colour of sample F had changed due to exposure. The closeness of the colours of the front and back face did show that even if the colour of weathered material had deteriorated, it could be returned to it's original appearance through surface sanding.

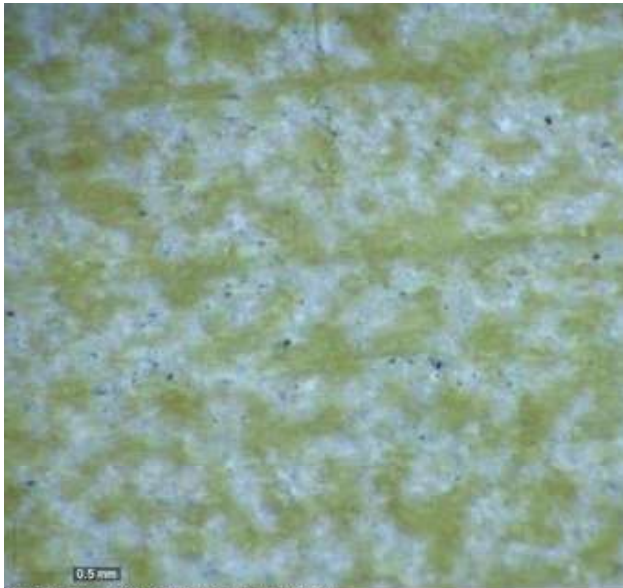
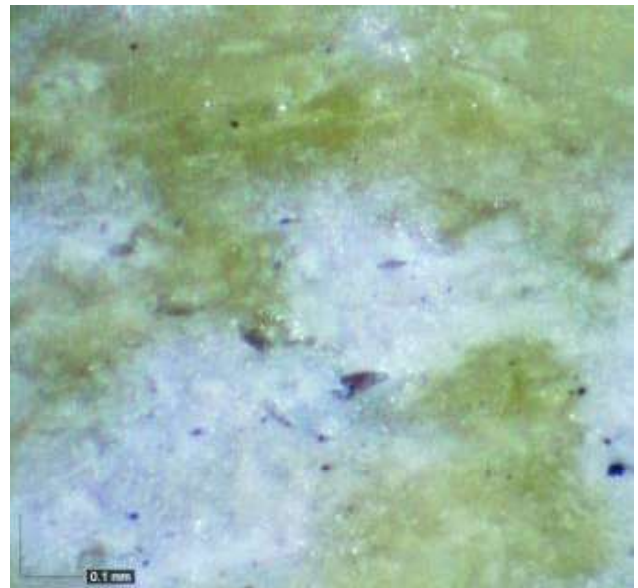
Figure 15 – Micrograph of the exposed region of the front face of Sample C at low magnification.

Figure 16 – Micrograph of the exposed region of the front face of Sample C at high magnification.

Clear differences can be seen between the exposed and unexposed regions of the front face of the 2.5 year old Sample C in Figures 15 to 18. Specifically, the exposed region of the front face shown in Figures 15 and 16 has bleached 'splotches' which, as previously noted, has resulted in a lighter colour when viewed without magnification. Similar bleaching was not apparent in the new Innowood of Sample A. Examination under the microscope (Figures 15 and 16) suggests that the colour change in Sample C was due to whitening in regions of the coating, and not due to changes in the underlying composite structure. Inspection of the micrographs of the un-weathered surfaces of the same sample (Figures 17-20) indicates that the beginnings of similar bleaching had occurred, albeit to a significantly lesser extent. No bleaching is discernable on the unexposed rear face of Sample C (Figures 19 and 20). The fact that examination of other older, sometimes uncoated samples does not reveal similar bleaching strengthens the hypothesis that the effect is confined to the coating, and is not indicative of deterioration of the composite timber structure. The bleaching is worst where the surface has been exposed to the elements, including sunlight, barely visible on the unexposed front face where the sunlight would have a very low intensity and not apparent on the rear face where sunlight is unlikely to penetrate, so it seems most probable that the bleaching is due to UV induced breakdown of the coating. As mentioned in section 4C, this deterioration is probably an anomaly related to a particular batch of coating or the technique or type of coating prevalent late in 2015.

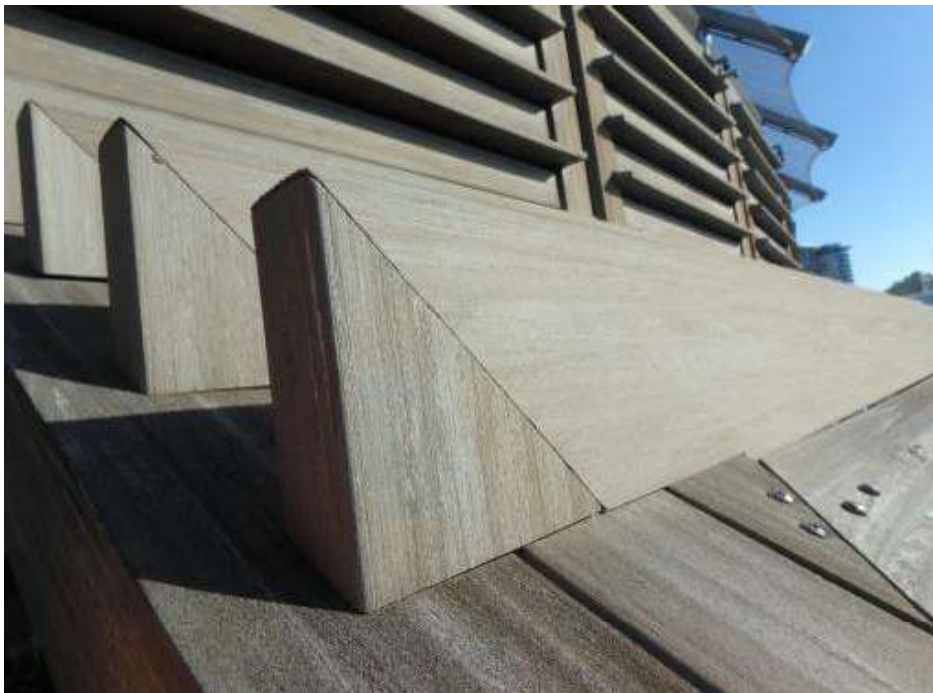
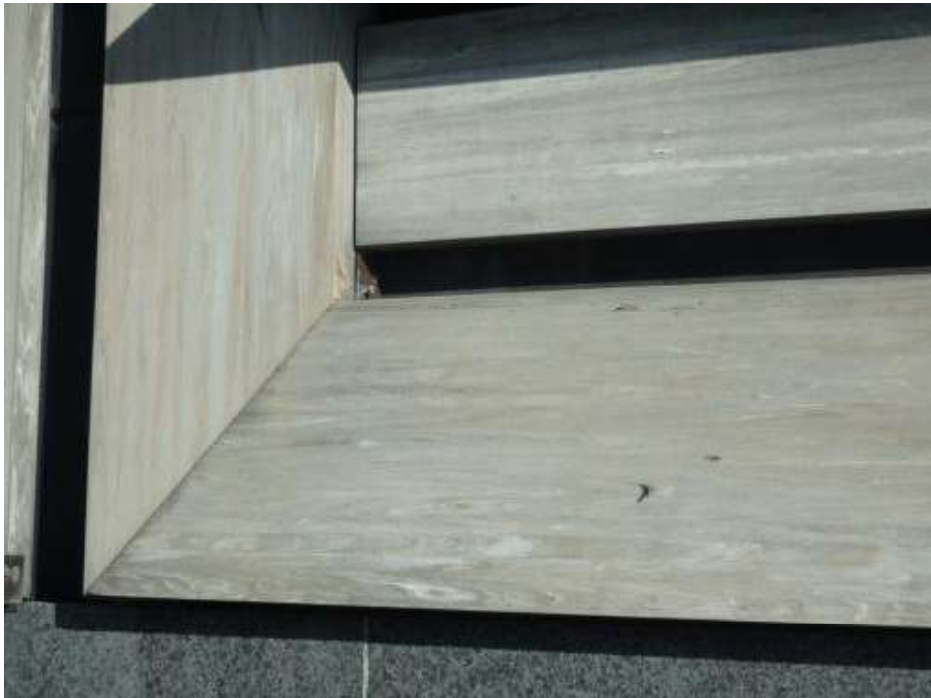
Figure 36 – Detailed view of the Wild Life Sydney Zoo Façade shade slats.

Figure 37 – Detailed view of 45° joints in a vertical section of the Wild Life Sydney Zoo Façade.

As shown in Figure 36, most of the Wild Life Sydney Zoo façade constructed from Innowood was fully exposed to the weather. Not shown in the photo, the building is located on a wharf adjacent to Darling Harbour, so in addition to sunlight, rain and wind, some exposure to salt spray would also have been expected.

The Innowood on this installation was in excellent condition despite 12 years of full exposure to the weather, as shown in Figures 36 and 37. In particular, there was no evidence of significant bleaching, surface erosion or shrinkage, the 45° and right-angle joints remained flush and the overall appearance was one of well-preserved weathered timber.

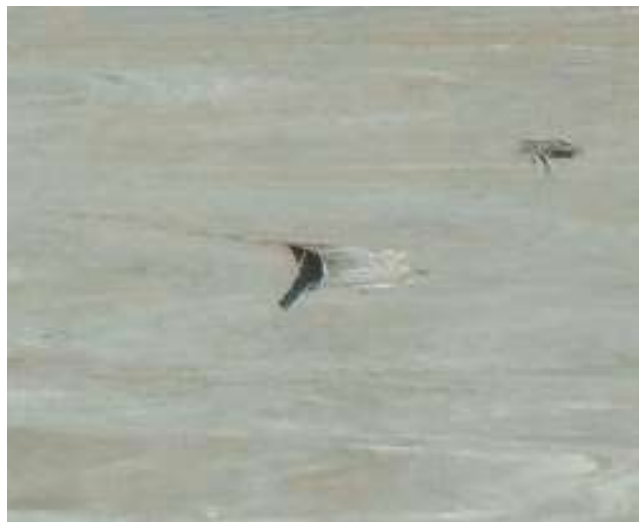
Figure 38 – Detail of (rare instance of) surface peeling in the Wild Life Sydney Zoo Façade

Careful, close inspection through the binoculars revealed a couple of instances of peeling of very thin surface layers (Figure 38), but this was very rare, required a very careful inspection of all surfaces and did not detract from the overall appearance of the façade.

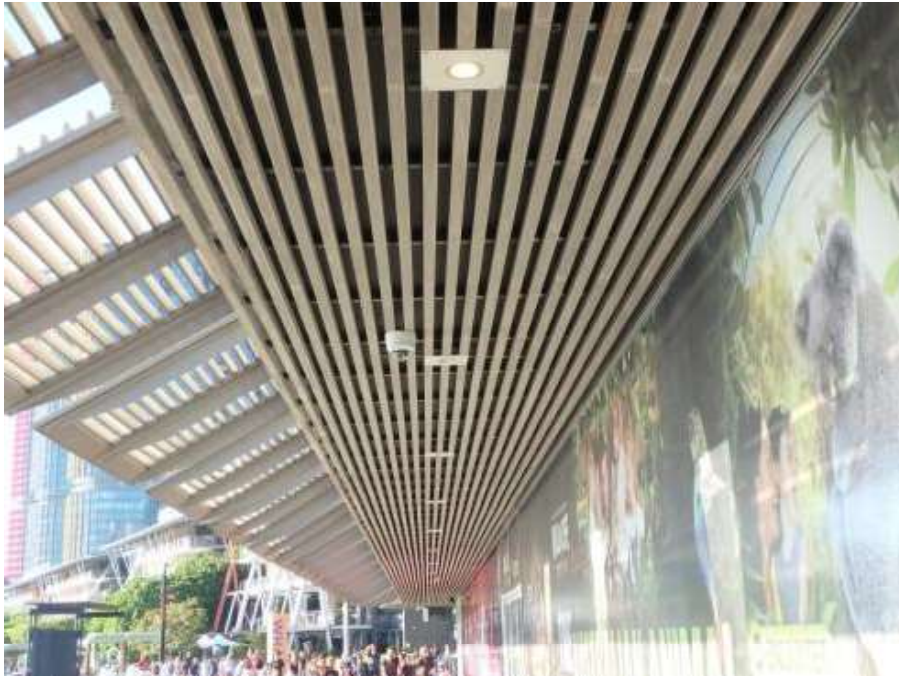
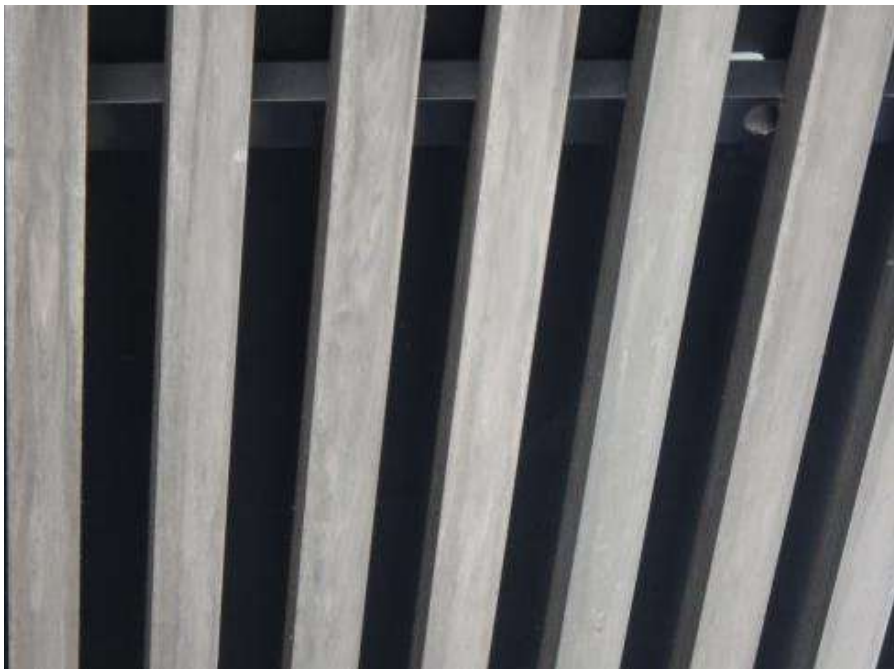
Figure 39 – General view of the slatted ceiling at the Wild Life Sydney Zoo

Figure 40 – More detailed view of the slatted ceiling at the Wild Life Sydney Zoo

Figures 39 and 40 show the area under the roof extending around the Wild Life Sydney Zoo, which was covered by thin ceiling slats of Innowood. Despite careful scrutiny, no evidence of degradation or damage could be seen in this less exposed material.

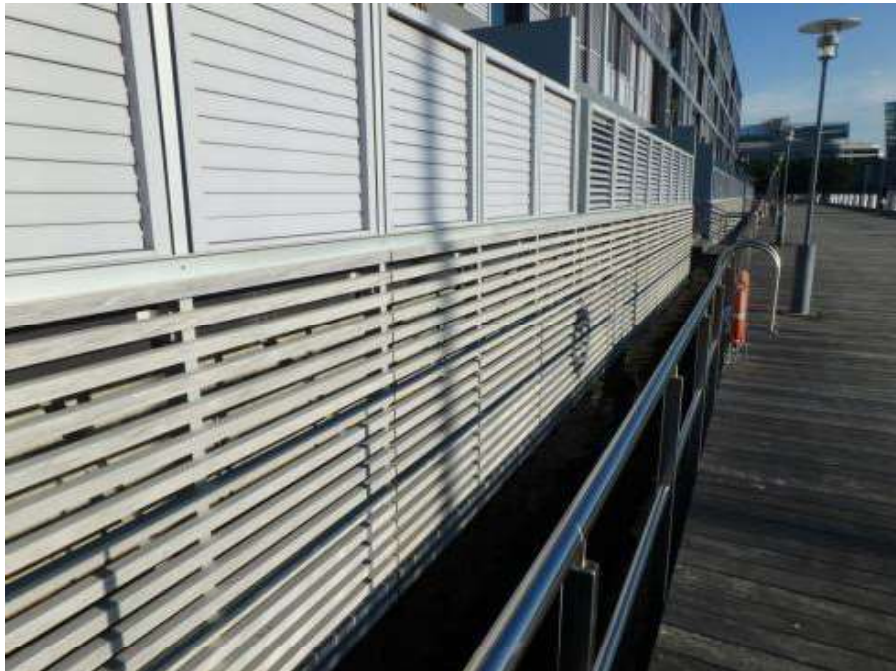
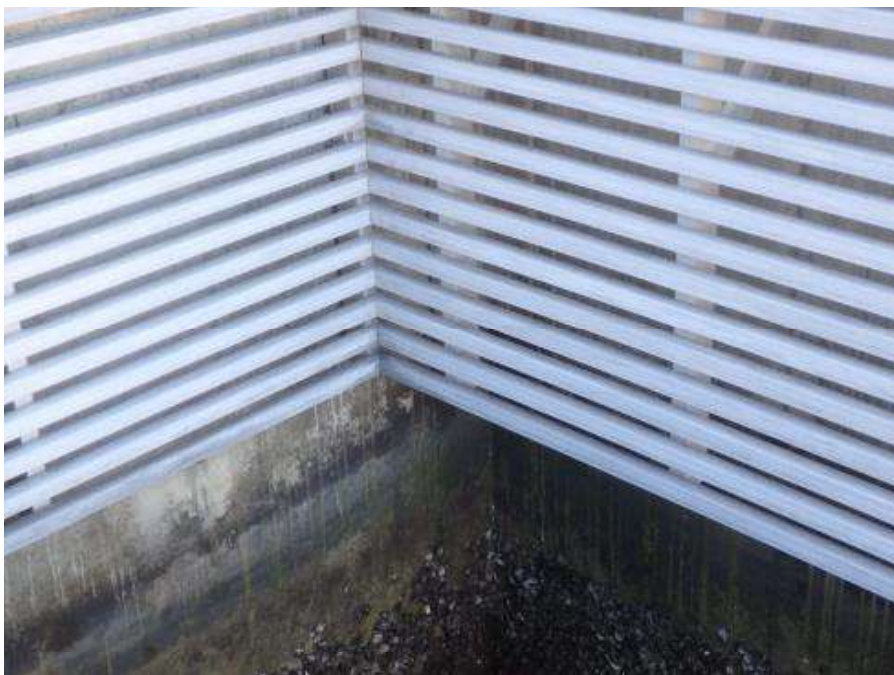
Figure 41 – General view of the slatted covering on the lower portion of the building walls at Pyrmont Wharves 8 and 9.

Figure 42 – View of the slatted covering on the lower portion of the building walls at Pyrmont Wharves 8 and 9 showing its close proximity to the high water level.

Figures 41 and 42 detail the Innowood slats that were placed over the lower walls of the residential buildings at Pyrmont Wharves 8 and 9 in 2007. As shown in Figure 42, the bottom slats are only just above the high water mark. Therefore, in addition to 11 years of exposure to sunlight, wind, rain and salt water spray, the lower slats would be expected to be regularly immersed in salt water due to wave action at high tide. This is a particularly aggressive weathering environment!

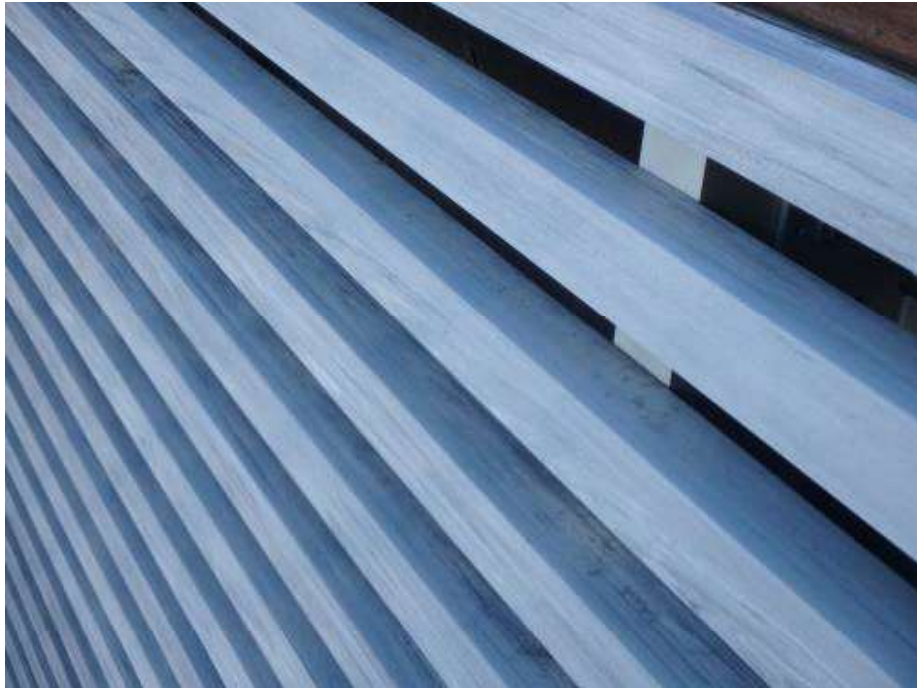
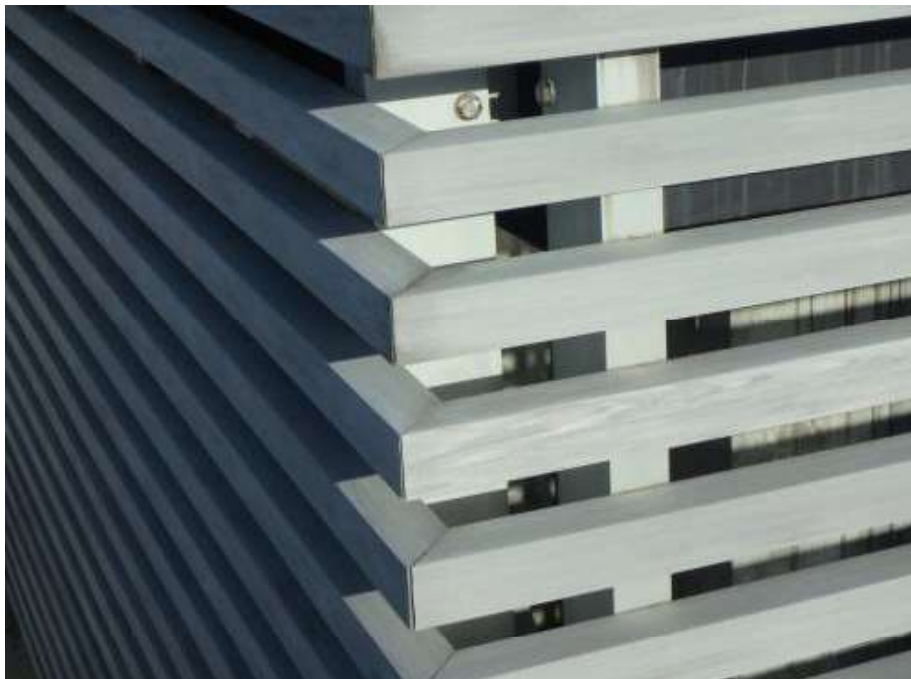
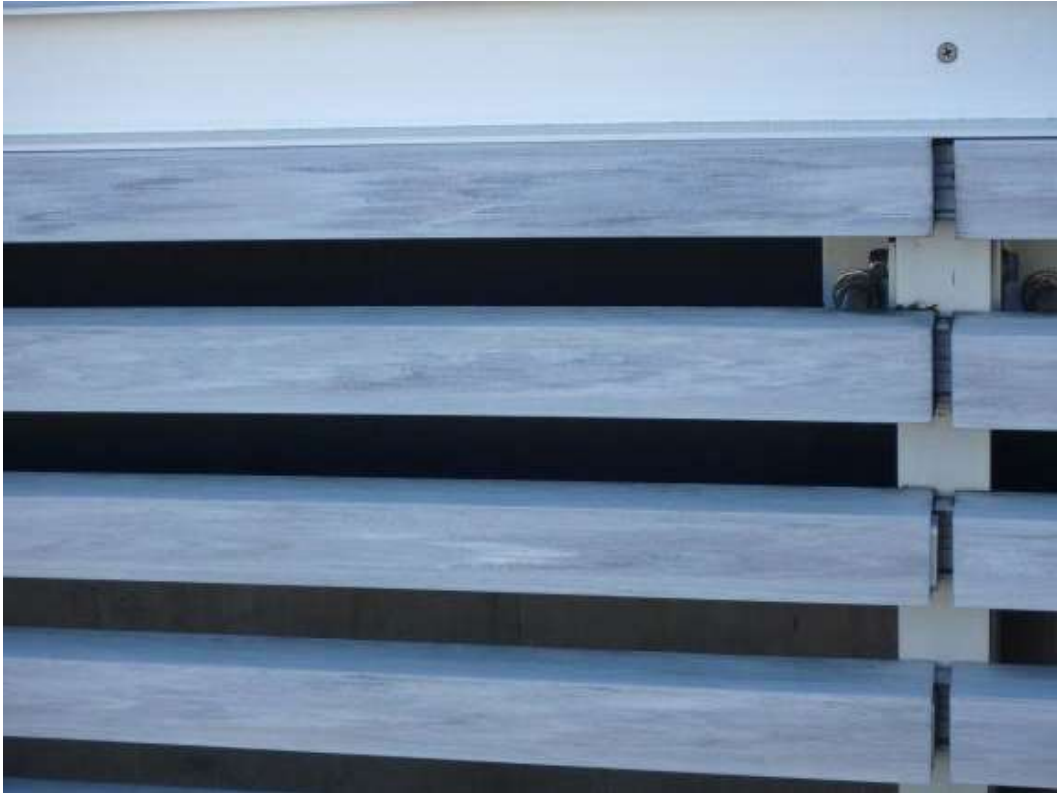
Figure 43 – Close-up of the slatted covering on the lower portion of the building walls at Pymont Wharves 8 and 9.

Figure 44 – Close-up of slatted covering corners on the lower portion of the building walls at Pymont Wharves 8 and 9.

Figure 45 – Close-up of the slatted covering expansion joints on the lower portion of the building walls at Pymont Wharves 8 and 9.

Despite very careful scrutiny, there was no evidence of surface erosion or significant bleaching as evidenced by Figures 43 to 45, and the composite timber still gave the appearance of weathered, natural timber in good condition. (Note that natural timber was highly unlikely to have survived that well after 11 years in that environment). Indeed, the slight darkening seen in the bottom corner of the slat covering shown in Figure 42 was typical of the worst of the discolouration observed, and much more appealing than the appearance of the concrete surface it covered. No significant mould, moss or other biological growth could be seen on the surface of the Innowood slats. Figure 45 details what was thought to be an expansion joint between the slats covering the walls; any shrinkage would have been masked by the expansion joint gap.

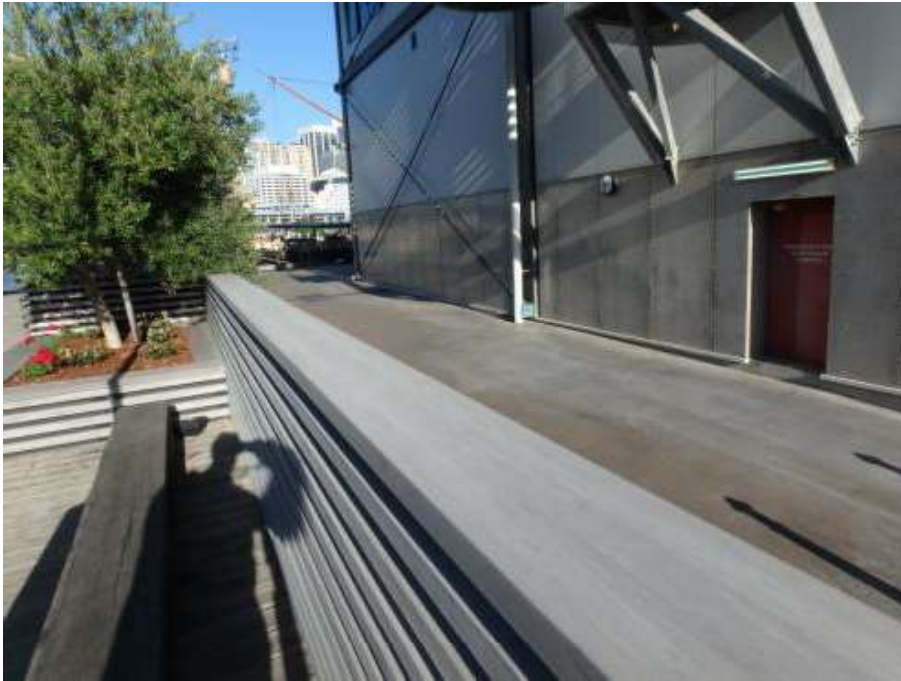
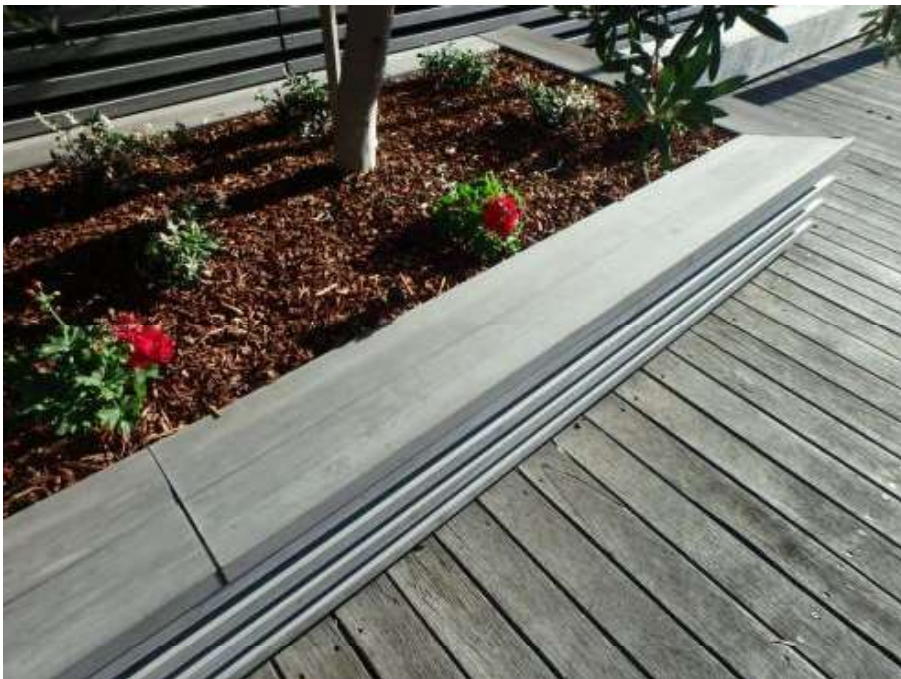
Figure 46 – General view of the planter surrounds and wall feature in front of Pymont Wharves 8 and 9.

Figure 47 – Planter surrounds in front of Pymont Wharves 8 and 9.

Figures 46 and 47 show the general siting of the Innowood planter surround and wall feature between Pyrmont Wharves 7 and 10 and Wharves 8 and 9. These constructions, erected in 2007, would have been exposed to the full effects of sunlight, wind, rain and salt spray for 11 years, and water would be expected to lie on the horizontal surfaces for a while after rain. Because of their location, these features were accessible to the public and both planter surrounds were of a height that they would have been expected to be regularly used as seats (which may have been an inappropriate use for this form of Innowood).

In the main, as can be seen in Figures 46 and 47, the Innowood used in the planter surround sand wall feature still looks like weathered timber in good condition. Figures 48 and 49 show images of the top and bottom surfaces of the top of the wall feature taken at an oblique angle looking towards a door. In the photo of the bottom surface, a reflection of the door can be seen, indicating that the Innowood surface is still shiny (as both surfaces presumably were when initially installed) while the top surface now has a matt surface (which is probably more akin to the weathered timber it simulates). The matt finish to the top surface is due to the formation of very small pits, which can be seen in the close-up photo of the surface shown in Figure 50; these pits are only visible if the surface is examined very closely. A small proportion of the vertical surfaces have also suffered minor surface peeling, as shown in Figure 51, which is also only evident upon very close examination, looks very like splinters of timber and, despite appearances, could not be scratched off.

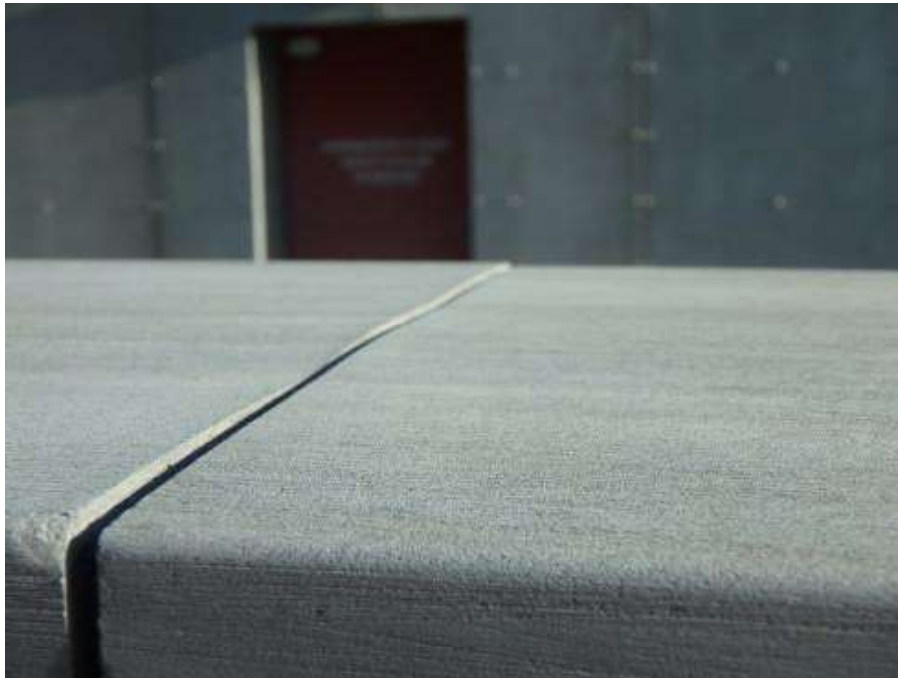
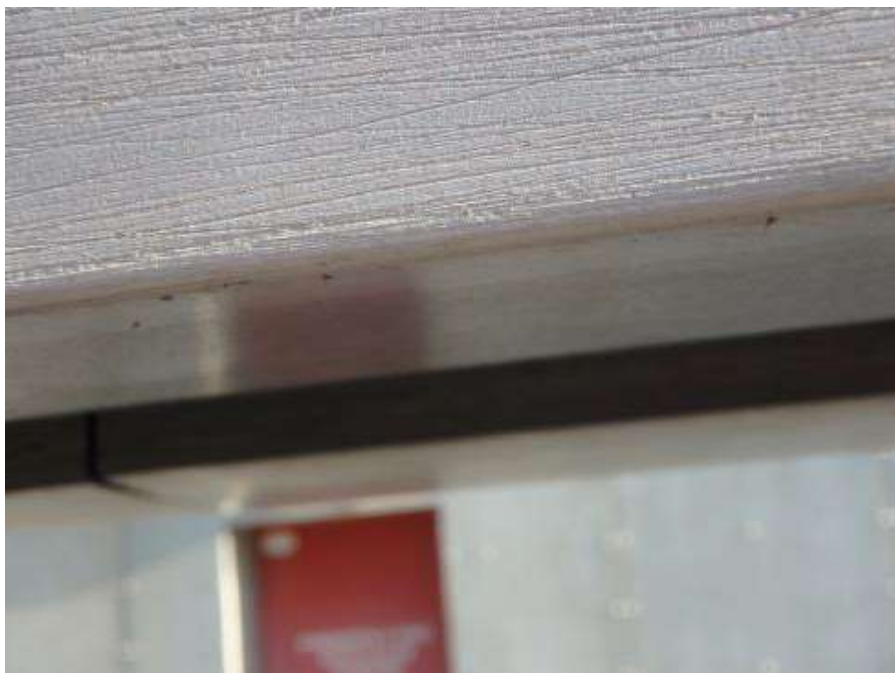
Figure 48 – Matt top surface of the wall feature in front of Pymont Wharves 8 and 9.

Figure 49 – Shiny under surface of the wall feature in front of Pymont Wharves 8 and 9, revealed by reflection of a door.

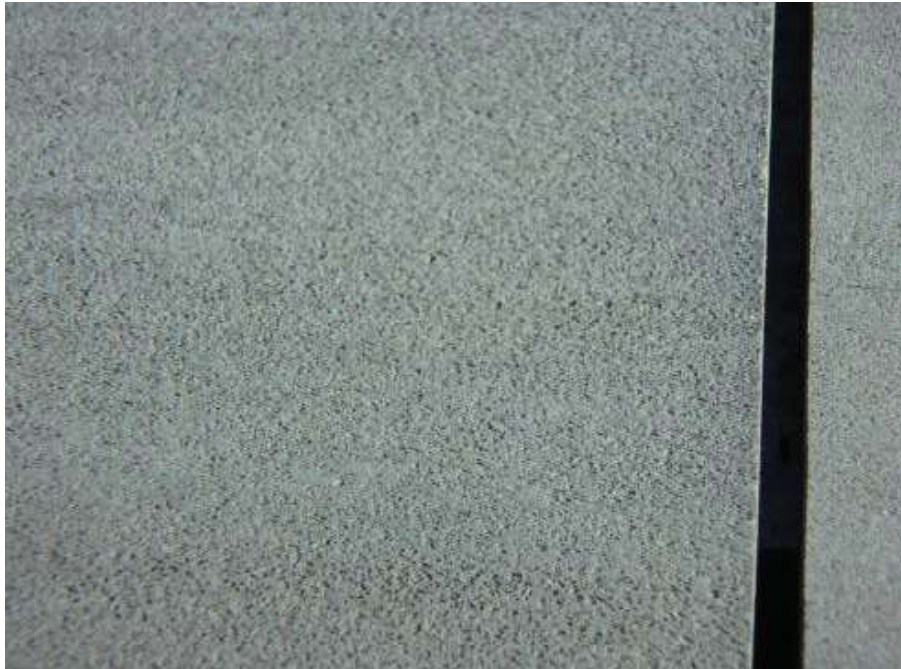
Figure 50 – Close-up of pits in the top surface of the wall feature in front of Pyrmont Wharves 8 and 9. The plank gap is ~5mm wide.

Unexpectedly, the surface pitting and minor surface peeling was not accompanied by poor hardness or surface integrity. Specifically, it was virtually impossible to create an observable indentation using very firm thumbnail pressure which, compared to new material, represents a significant increase in hardness. As for all new and weathered Innowood tested during this study, no material could be scratched off using a thumbnail scraped perpendicular or parallel to the 'grain'. In summary, despite 11 years of exposure, the surface integrity of this Innowood installation has been maintained and appeared harder than when first installed; it was not chalky.

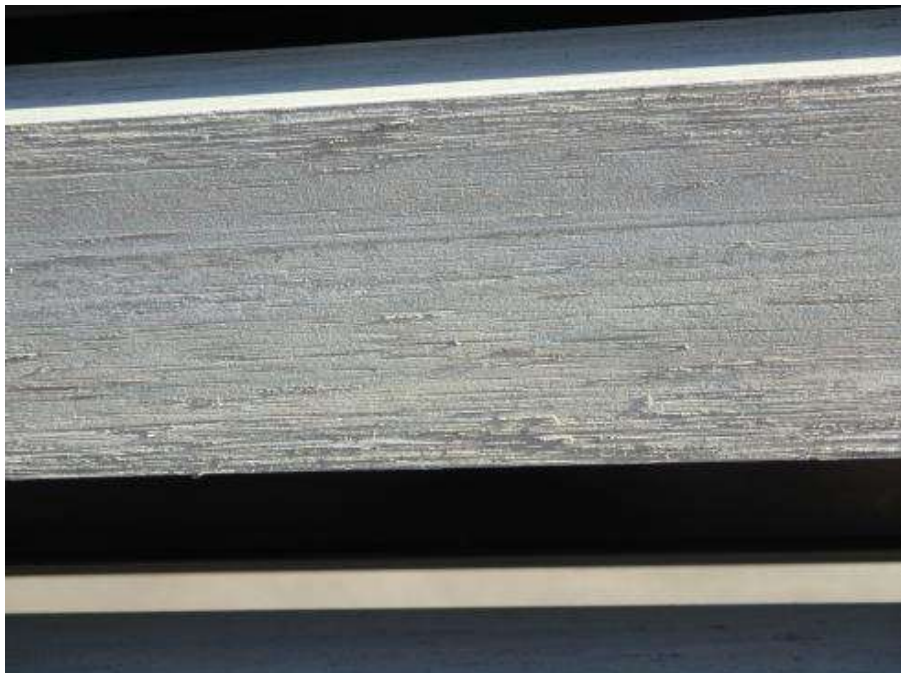
Figure 51 – Close-up of (a rare instance of) minor surface peeling in the side surface of the wall feature in front of Pyrmont Wharves 8 and 9.

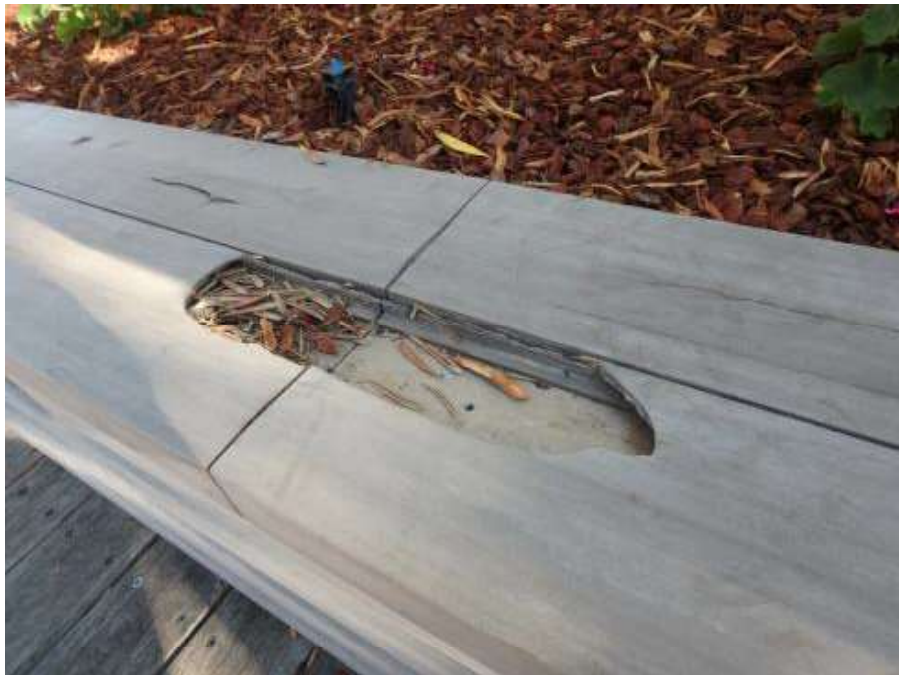
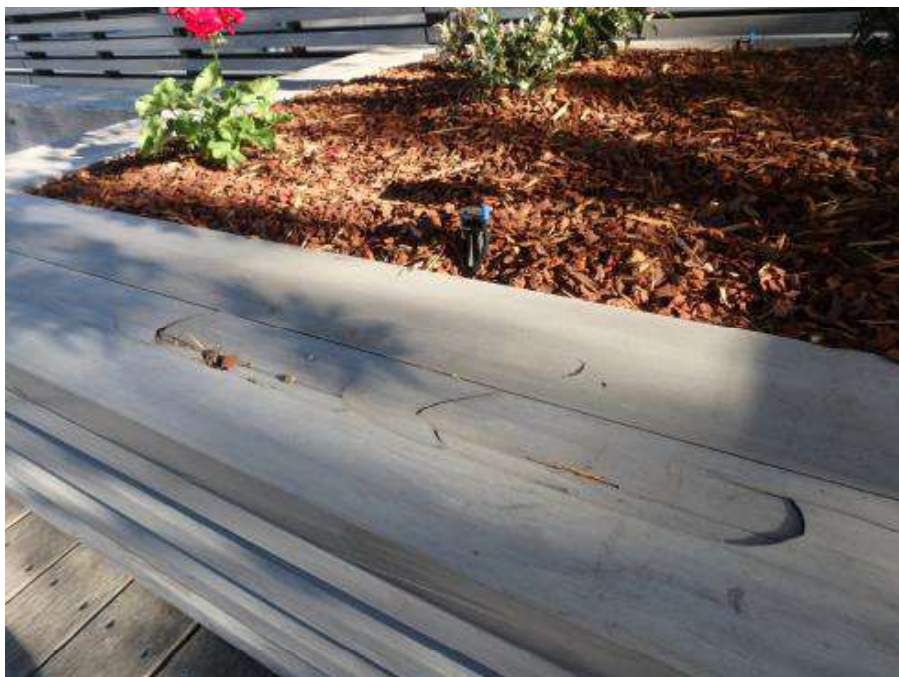
Figure 52 – Damage in part of the East planter surround in front of Pymont Wharves 8 and 9.

Figure 53 – Damage in part of the East planter surround in front of Pymont Wharves 8 and 9.

While the general condition of the planter surrounds and wall feature was very good, some damage to part of the Eastern planter surround was evident, as shown in Figures 52 to 56. Figures 52 and 53 show broken areas in the top surface of the Eastern planter surround, revealing the approximately 5mm wall thickness of the hollow-section plank. The material around the break was very tough, and it was not possible to break off additional material by hand. It may be relevant that the regions where material had been removed (Figures 52 and 54) were at joins, where it would have been possible to insert a lever. Figure 55 shows what looks like a tyre scrape mark and impact damage by an approximately 15mm circular implement while Figure 56 shows another tyre mark and edge scrape, both in the walls of the Eastern planter surround near the damage to the top surface.

Nevertheless, the apparent toughness of the material in the region of the damage shown in Figures 52 to 56, the very good condition of the remainder of the planter surrounds, wall feature and slats on the lower walls of the Wharf 8 and 9 buildings, the location of the damage in Figures 52 and 54 and evidence of tyre marks in Figures 55 and 56 all suggest that the damage is due to significant force; tentatively attributed to a combination of impact by heavy gardening equipment, determined vandalism and its use as a 'BMX bike obstacle'. More importantly, it seems unlikely that the damage in part of the Eastern planter surround was due to deterioration of the Innowood as a result of weathering.

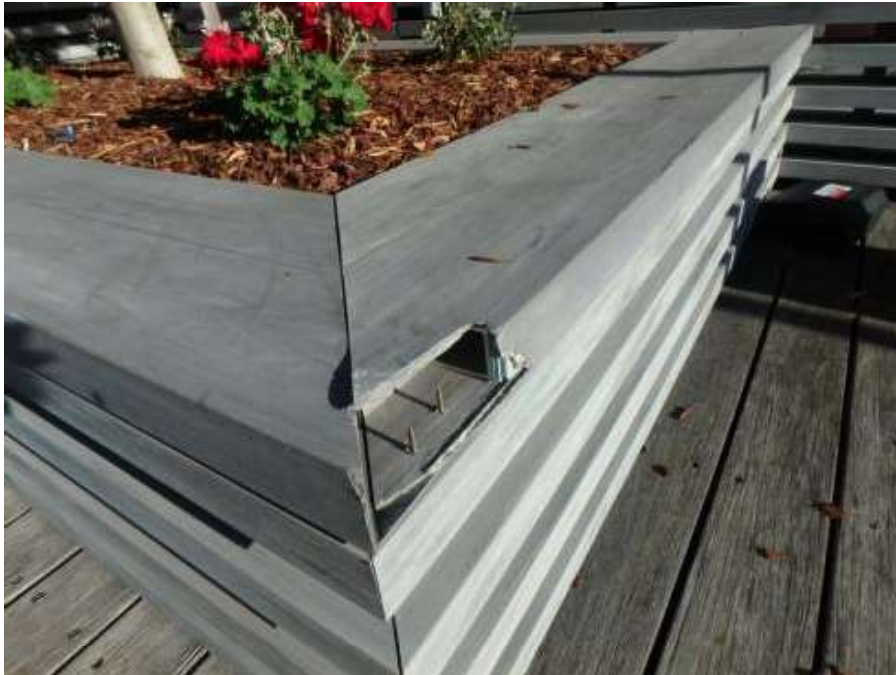
Figure 54 – Corner damage in the West planter surround in front of Pymont Wharves 8 and 9.

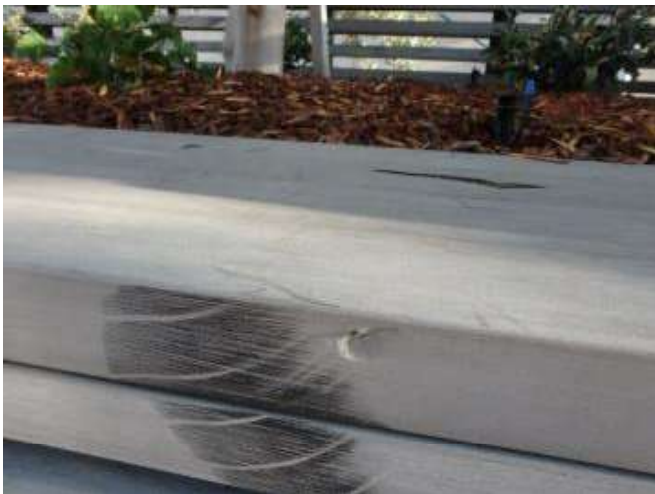
Figure 55 – Tyre marks and impact indentation in the East planter surround in front of Pymont Wharves 8 and 9.

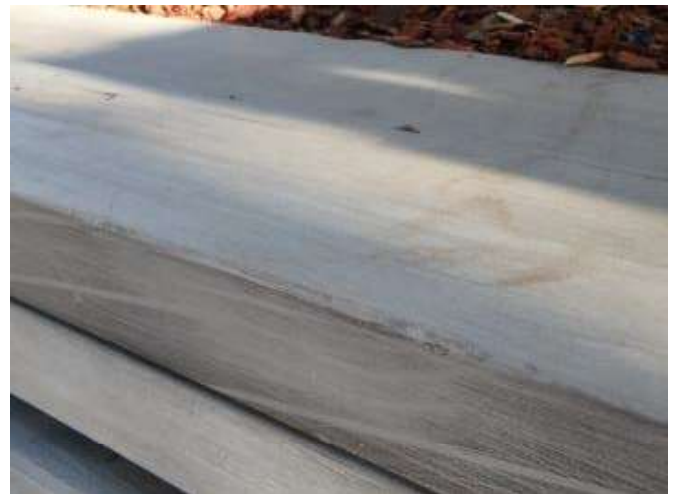
Figure 56 – Corner scrape in the East planter surround in front of Pymont Wharves 8 and 9.
