**Observation and Microscopy
of
New and Weathered Innowood**

**by
Dr Tim Dabbs**

5th April, 2018

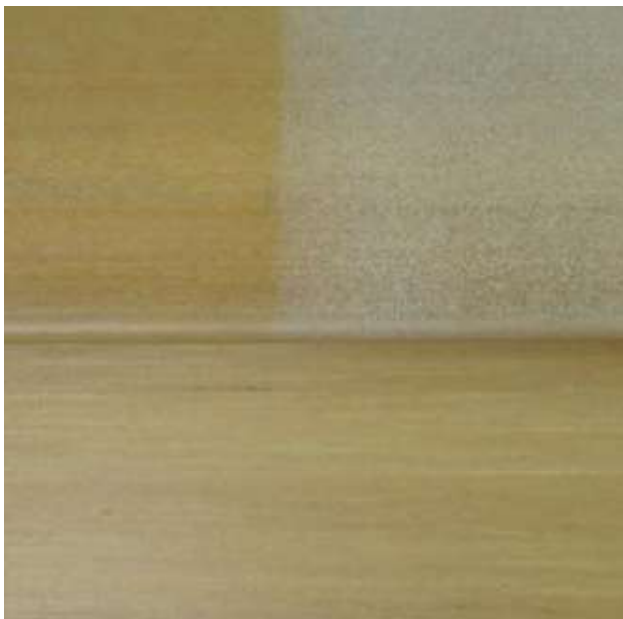
Figure 3 – Sample C front face (top) held against the Golden Oak colour sample. The exposed region of the front face of sample C can be seen top right.

The weathered portion in sample C (Figure 3) was clearly lighter in shade than both the un-weathered front and rear portions of sample C, which seemed very close in colour to the 'Golden Oak' colour panel. As discussed later, this bleaching could have been related to UV induced breakdown of the coating. No similar whitening was apparent in fresh material (sample A) or on the exposed or unexposed faces of weathered samples D, E and F; the observation of whitening was confined to a single sample and thus it was postulated that the bleaching was probably an anomaly related to a particular batch of coating or the technique or type of coating prevalent late in 2015.

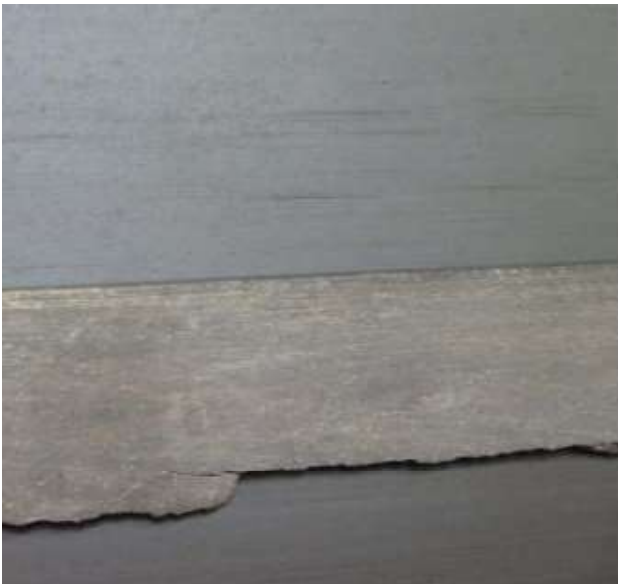
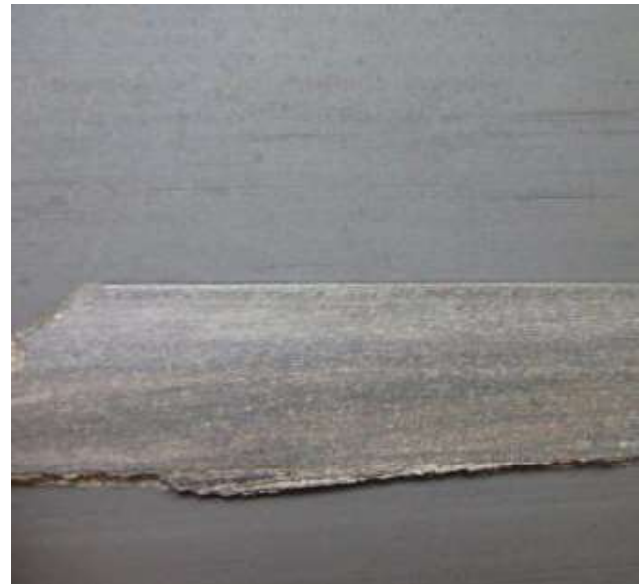
Figure 7 – Sample E exposed face held against the Weathered Wood colour sample.

Figure 8 – Sample E unexposed face held against the Weathered Wood colour sample.

The best evidence regarding colour change was provided by the front and rear face of sample E (Figures 7 and 8), which was thought to be initially similar in colour to the 'Weathered Wood' panel. It can be seen that the (uncoated) rear face had light and dark regions and streaks of colour which, on average, match the colour and tone of the (coated) 'Weathered Wood' panel. In contrast, the front face had less variation in both colour and tone and was, on average, lighter than the 'Weathered Wood' panel. Thus, it may be inferred that exposure had bleached the colour and lightened the tone of this sample, although the changes were relatively small.

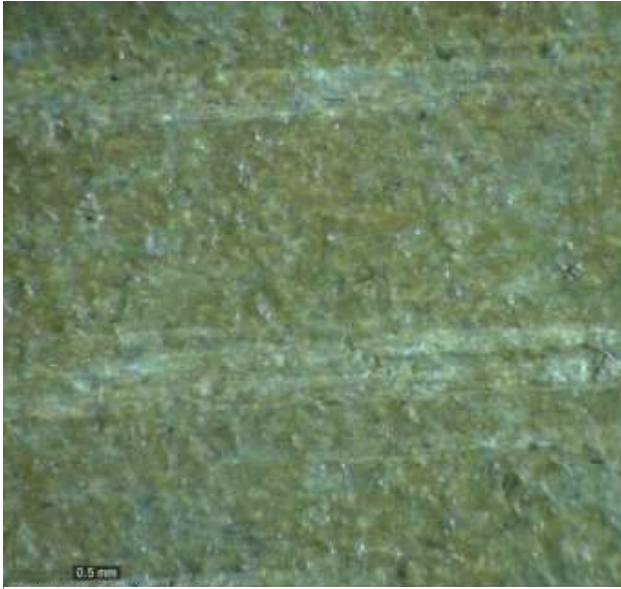
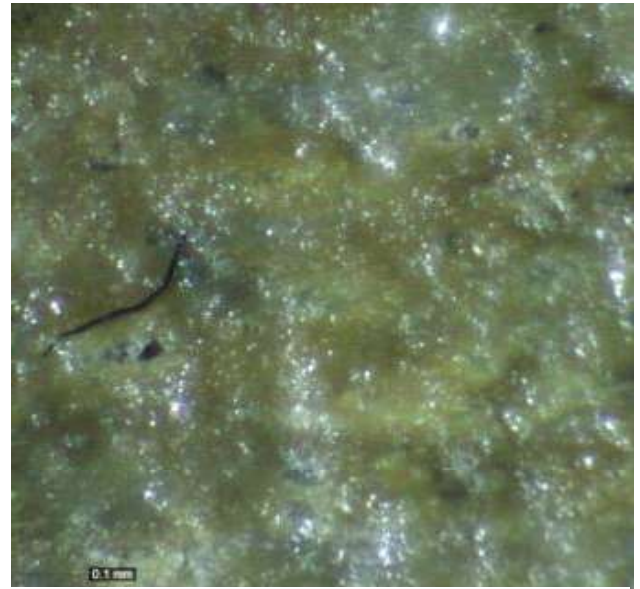
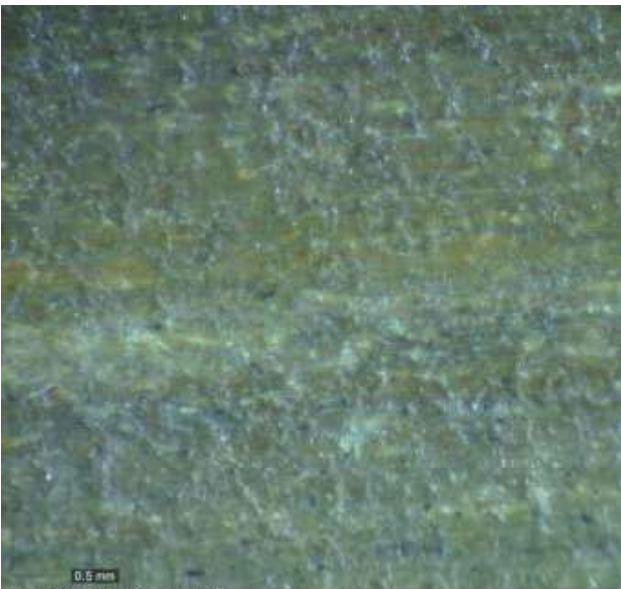
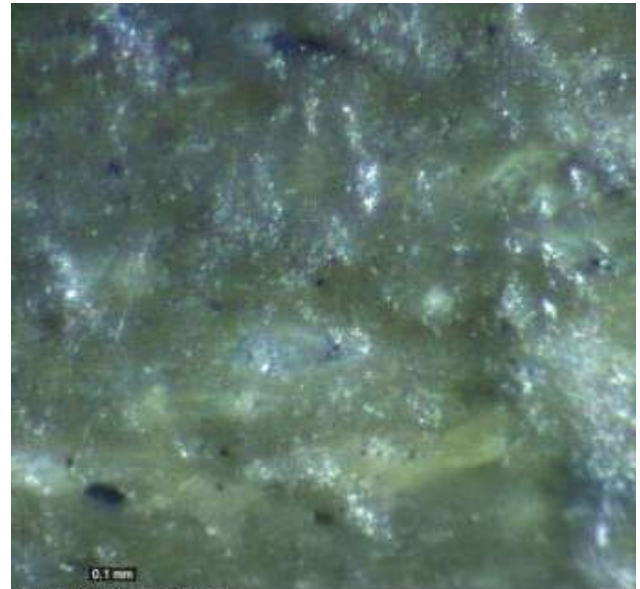
Figure 11 – Micrograph of the front face of Sample A at low magnification.

Figure 12 – Micrograph of the front face of Sample A at high magnification.

Figure 13 – Micrograph of the rear face of Sample A at low magnification.

Figure 14 – Micrograph of the rear face of Sample A at high magnification.

Figures 11 to 14 show the front and rear faces of the new material of Sample A, which look identical at their respective magnifications. This was not necessarily expected as the front and back of the extrusion die may not have produced the same conditions of pressure or may have had different frictional properties, for example. While it must be borne in mind that this sample was fabricated using a different extrusion die to the other samples, and had a different coating regime, it suggests that the exposed front and unexposed back faces of the weathered samples began with a similar appearance. Therefore, if differences are observed between the exposed and unexposed regions of the weathered samples, they should be attributable to the effects of the weather.

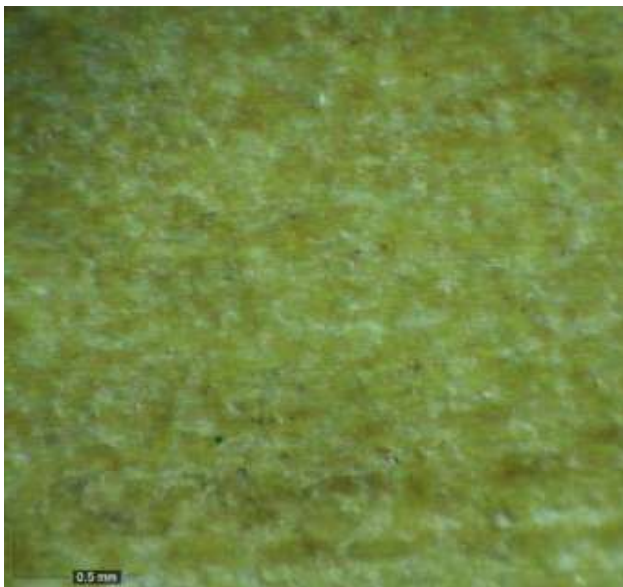
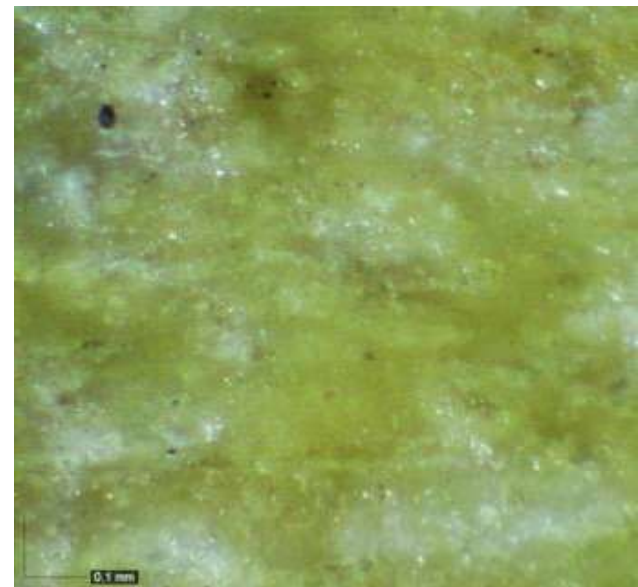
Figure 17 – Micrograph of the unexposed region of the front face of Sample C at low magnification.

Figure 18 – Micrograph of the unexposed region of the front face of Sample C at high magnification.

Clear differences can be seen between the exposed and unexposed regions of the front face of the 2.5 year old Sample C in Figures 15 to 18. Specifically, the exposed region of the front face shown in Figures 15 and 16 has bleached 'splotches' which, as previously noted, has resulted in a lighter colour when viewed without magnification. Similar bleaching was not apparent in the new Innowood of Sample A. Examination under the microscope (Figures 15 and 16) suggests that the colour change in Sample C was due to whitening in regions of the coating, and not due to changes in the underlying composite structure. Inspection of the micrographs of the un-weathered surfaces of the same sample (Figures 17-20) indicates that the beginnings of similar bleaching had occurred, albeit to a significantly lesser extent. No bleaching is discernable on the unexposed rear face of Sample C (Figures 19 and 20). The fact that examination of other older, sometimes uncoated samples does not reveal similar bleaching strengthens the hypothesis that the effect is confined to the coating, and is not indicative of deterioration of the composite timber structure. The bleaching is worst where the surface has been exposed to the elements, including sunlight, barely visible on the unexposed front face where the sunlight would have a very low intensity and not apparent on the rear face where sunlight is unlikely to penetrate, so it seems most probable that the bleaching is due to UV induced breakdown of the coating. As mentioned in section 4C, this deterioration is probably an anomaly related to a particular batch of coating or the technique or type of coating prevalent late in 2015.

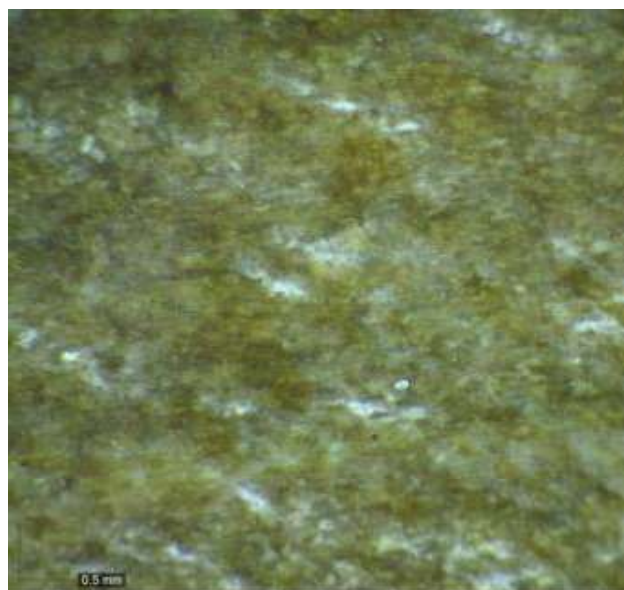
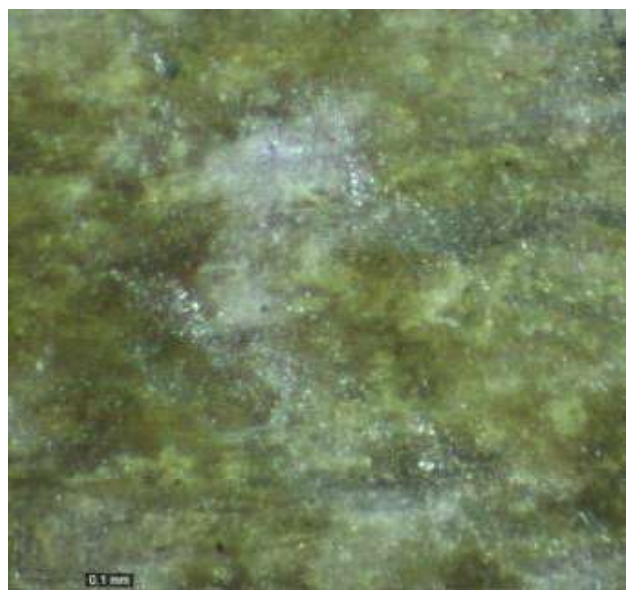
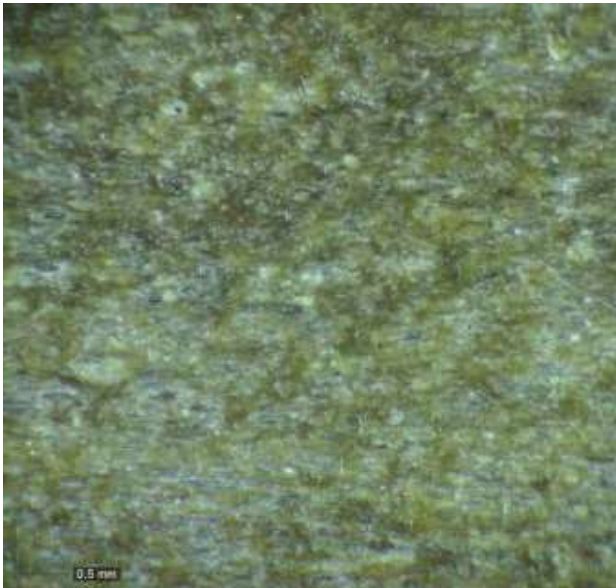
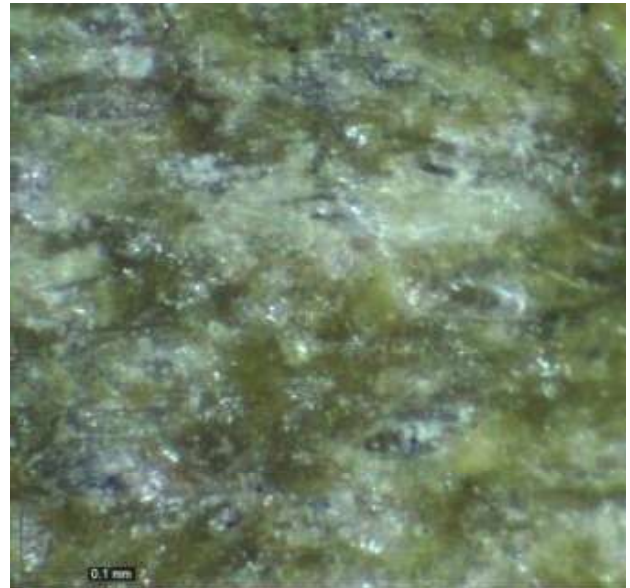
Figure 21 – Micrograph of the exposed front face of Sample D at low magnification.

Figure 22 – Micrograph of the exposed front face of Sample D at high magnification.

Figure 23 – Micrograph of the unexposed rear face of Sample D at low magnification.

Figure 24 – Micrograph of the unexposed rear face of Sample D at high magnification.

Bearing in mind the masking effect of the coatings, no significant differences can be seen between the rear and re-coated front faces of the six year old Sample D shown in Figures 21 to 24, both of which are similar to Sample A. In particular, there is no evidence of pitting or other surface erosion in the exposed, coated face of Sample D and even the distribution of pigment looks similar, particularly at the higher magnification. While this suggests that no deterioration in the Innowood has occurred due to exposure to the elements, because the front face has been recoated it is impossible to determine whether this would have been the case if it had been left without additional protection. On the other hand, this sample indicates that recoating Innowood protects or rejuvenates the surface to achieve an appearance very similar to that of fresh material (and the un-exposed rear surface).

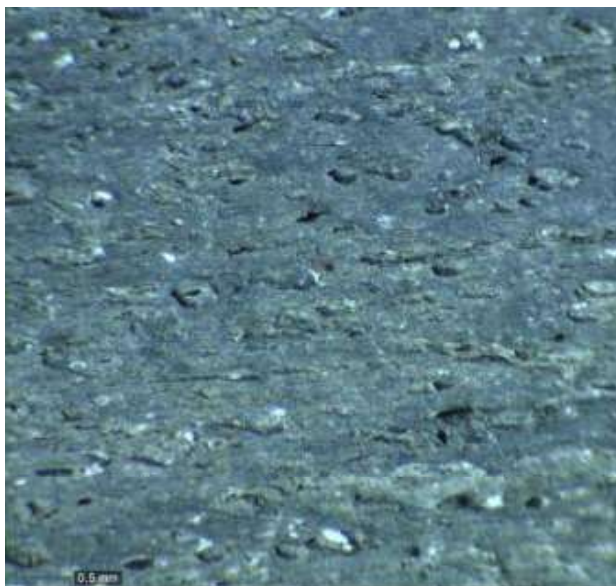
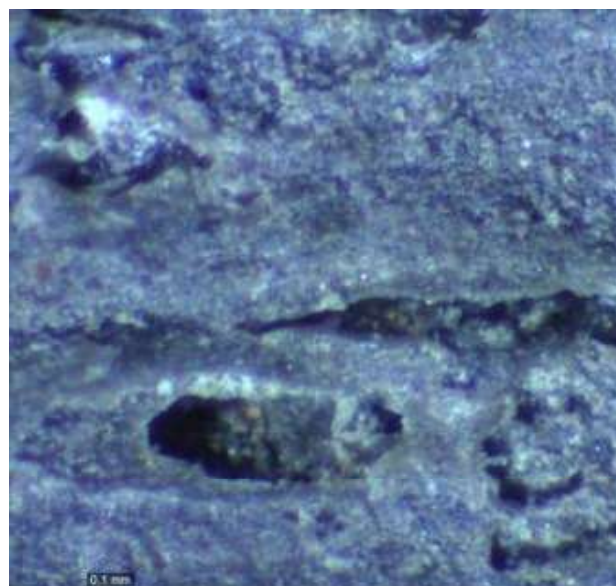
Figure 27 – Micrograph of the exposed front face of Sample E at low magnification.

Figure 28 – Micrograph of the exposed front face of Sample E at high magnification.

When combined with the inspections at the Wild Life Sydney Zoo and Pymont Wharves, examination of the front and rear face of Sample E in Figures 27 to 30 gave a good indicator of the effects of weathering as the sample had been exposed for 12 years. Firstly, although this material had not been coated there was what appeared to be a glossy finish to the rear, unexposed face of the sample which looked similar to new, coated Innwood. In contrast the exposed surface of the sample had a matt appearance, although it was not as rough and pitted as the surface shown in Figure 50, which had a horizontal installation orientation and thus would have been covered with water after rain. Under the microscope, the source of the glossy sheen on the unexposed face of Sample E was due to what looked like excess PVC resin at the surface (Figures 29 and 30), which was no longer visible on the exposed front face shown in Figures 27 and 28. As it is probable that both surfaces were exposed to rain and salt-laden wind, the most likely cause of the loss of gloss would be exposure to UV light from the sun, which is known to discolour and break the chemical bonds in PVC. The weathered surface had a high hardness, indicating that the surface breakdown had halted, possibly due to UV light blocking by pulp and dye, leaving behind a durable surface that was harder than the original, PVC-laden surface; this hypothesis could be tested by doing a chemical analysis across a section through new and weathered material.

The other feature evident in the weathered surface of Figures 27 and 28 was the appearance of small pores. Under the microscope it appeared as if the pores were an infrequent close-surface feature so it was unlikely that the weathered material was porous for any depth. This theory is supported by the fact that the surface was hard, not friable, and could be quantified in future by conducting vacuum-assisted water absorption measurements. No pits or surface peeling, such as portrayed by Figures 38, 50 and 51, were present in Sample E so these features could not be examined microscopically.

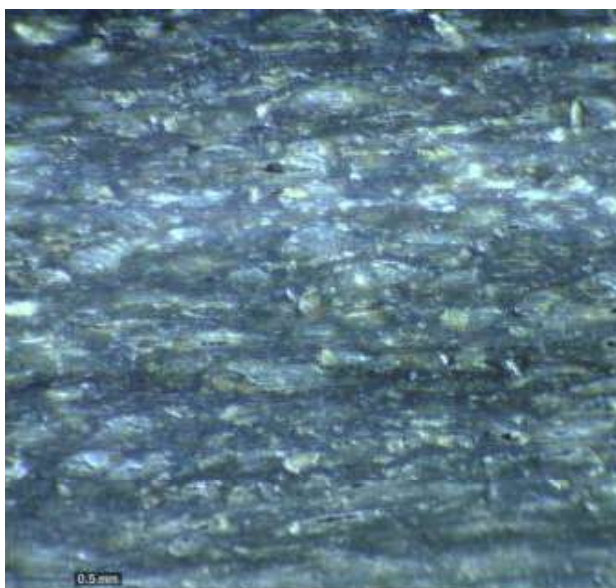
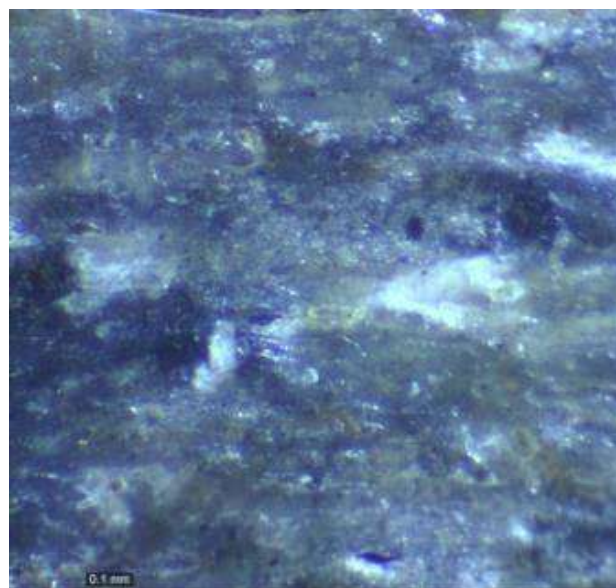
Figure 29 – Micrograph of the unexposed rear face of Sample E at low magnification.

Figure 30 – Micrograph of the unexposed rear face of Sample E at high magnification.
